The Reality of Plasma Cut Holes

Plasma cutting in recent years has seen several hole cutting "technologies" emerge, all claiming to be able to plasma cut holes down to 1:1 ratio (hole diameter to plate thickness) and sometimes even less. All while achieving good quality and relatively round cutting. This is most certainly true. However, it is important to understand that the Plasma cutting process is dependent on several factors, to name a few; pierce height, cutting height, cutting speed, gas pressures, current control, consumable degradation, CNC machine type and condition etc. Suffice to say, when cutting holes (especially as the diameter approaches 1:1) the result can be surprisingly inconsistent. This is despite latest technologies that use tried-and-tested parameters to achieve a "True" hole...

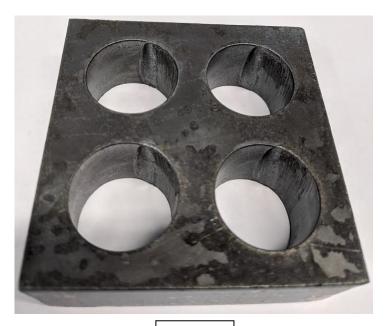
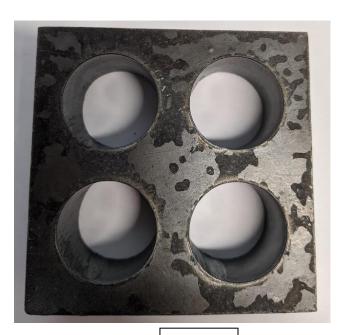
For example, the below 80mm x 80mm part was cut on a PCS Heavy Duty series machine with a High Definition plasma system. It is from 25mm Mild Steel and has 25mm diameter holes (1:1).

TOP SIDE

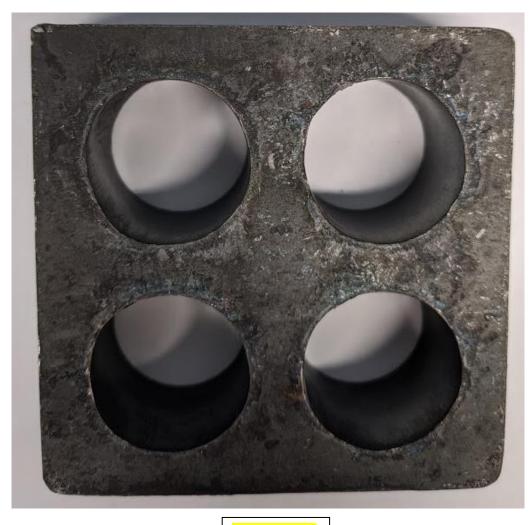
BOTTOM SIDE

The most honest presentation of a plasma cut hole is its bottom side. Here is traditionally where plasma has earnt the least respect when cutting holes. But as you can see, it is possible to cut respectful holes using a High Definition plasma system and a flavour of cutting technology – in this case PCS Xcel Cut^{TM} .

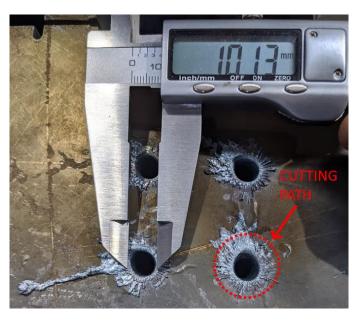
Firstly, in thicker material (such as our sample shown) the holes needed to be pre-pierced. This is because the molten metal (a.k.a SLAG) produced while piercing spreads into what will be the cutting path to produce the hole. When the plasma torch cuts over slag, the plasma arc can deviate slightly and effect the roundness of the hole, notably on the bottom side.

The solution is to pre-pierce and then manually remove the slag. The torch can then Edge Start on the already pierced hole which will produce no slag build-up and therefore cut the hole unimpeded by slag.
